**AGENDA
CITY OF HARRISONVILLE
HISTORIC PRESERVATION COMMISSION
REGULAR MEETING
CITY HALL
JULY 1, 2026
12:00 PM**

MINUTES
CITY OF HARRISONVILLE
HISTORIC PRESERVATION COMMISSION
REGULAR MEETING
CITY HALL
JUNE 3, 2026
12:00 PM

The Applicant has requested Certificates of Appropriateness to allow for the recently replaced windows and to change the color (paint) as indicated in the Paint Colors attachment.

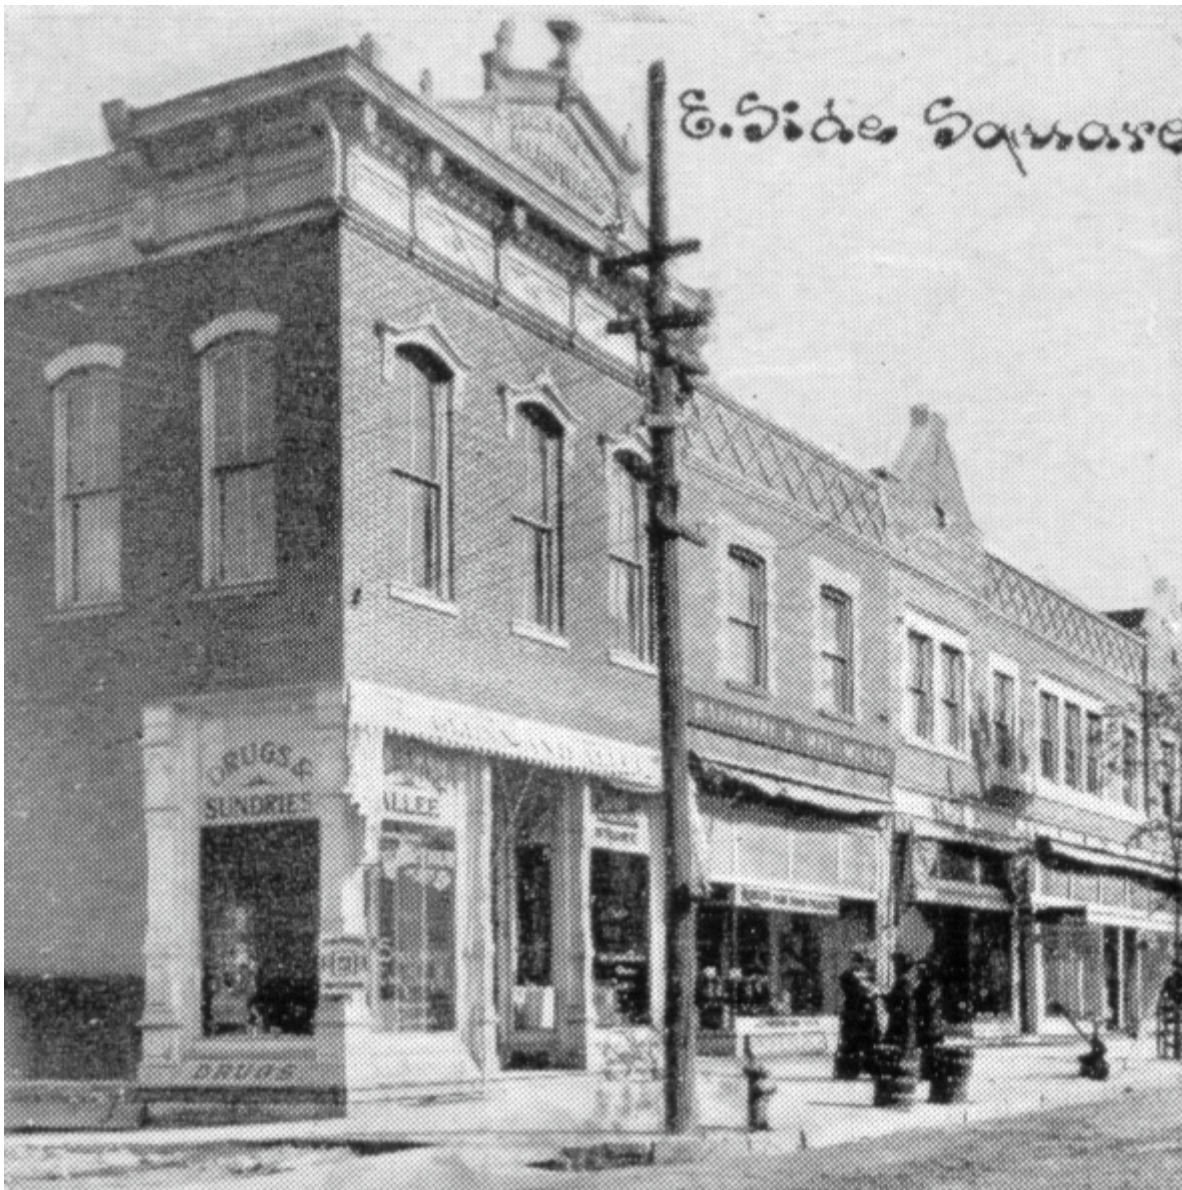
Snip of 1911 Postcard

“A 1911 postcard shows the original façade which had a much more elaborate cornice with a central pediment. Windows on the second story were 2/2 arched windows with pediment hoods. The storefront still had the recessed entry with cast iron pilasters and bulkheads. Signboards were above the display windows on the western and northern elevations. The current state of the façade is similar to its appearance in the 1970s and 1980s. During the time of the 1991 survey, the transom was covered with lattice.”

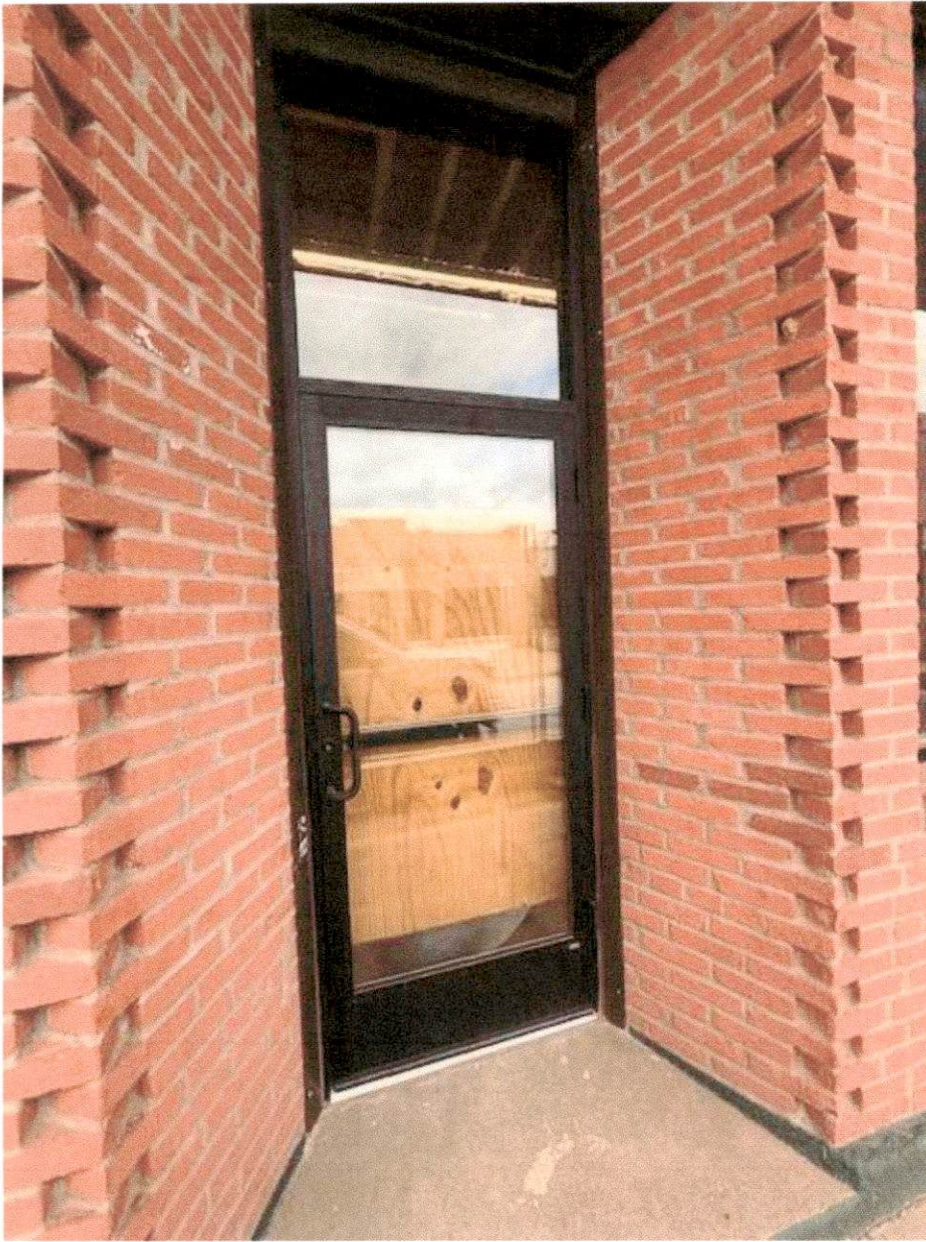
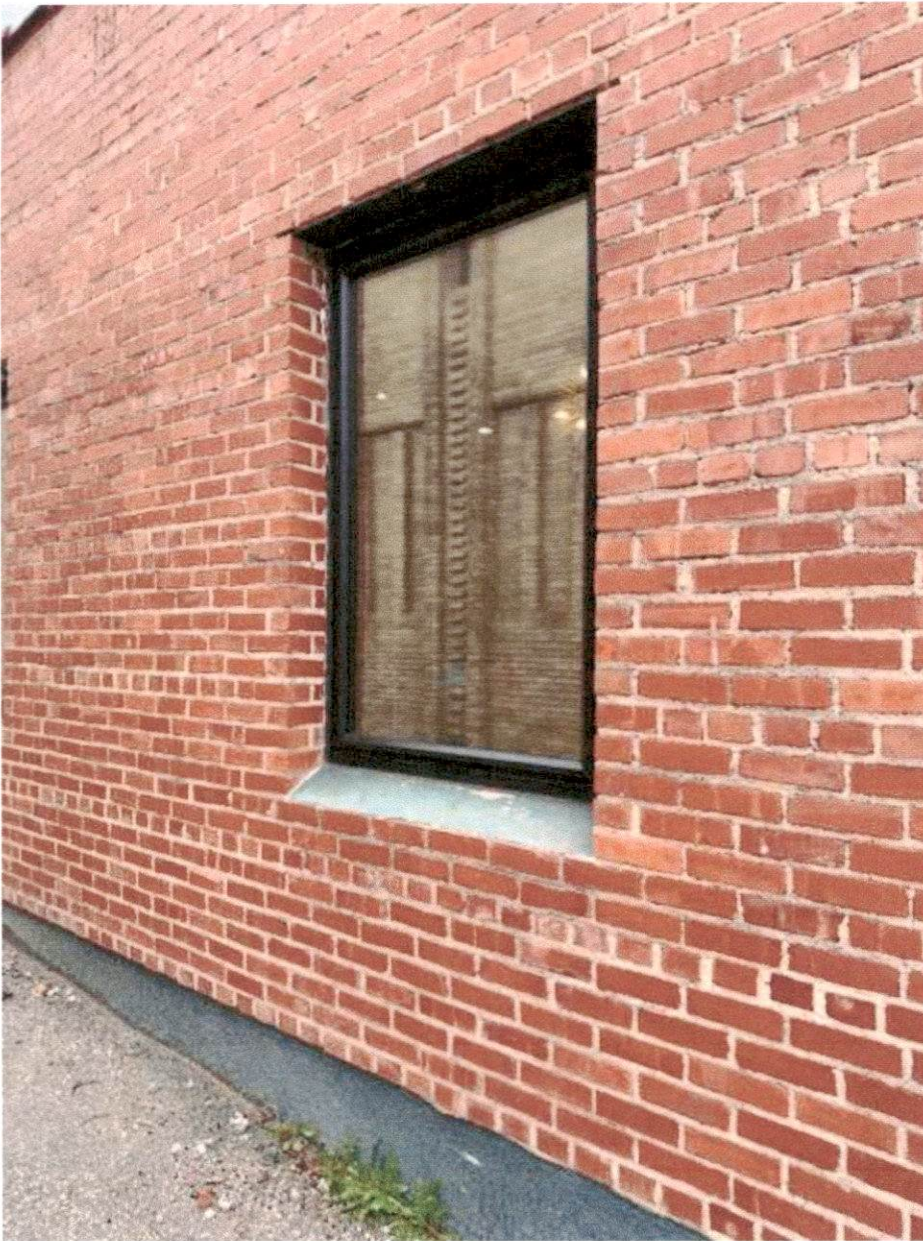
* Second Floor Windows

- Window manufacturers do not make single hung windows in excess of 84". With the openings of the existing windows being 102½" we had to add transom windows above the single hung windows. The openings from 103 & 101 were different. We decided we needed to match the window sizes and adjust the transom size. That is why the transoms are different sizes. We looked around the scene and old & New windows both have the transom windows some smaller and some larger. Plenty of older windows have transoms of many sizes creating the historic look of the window relative to what we did.

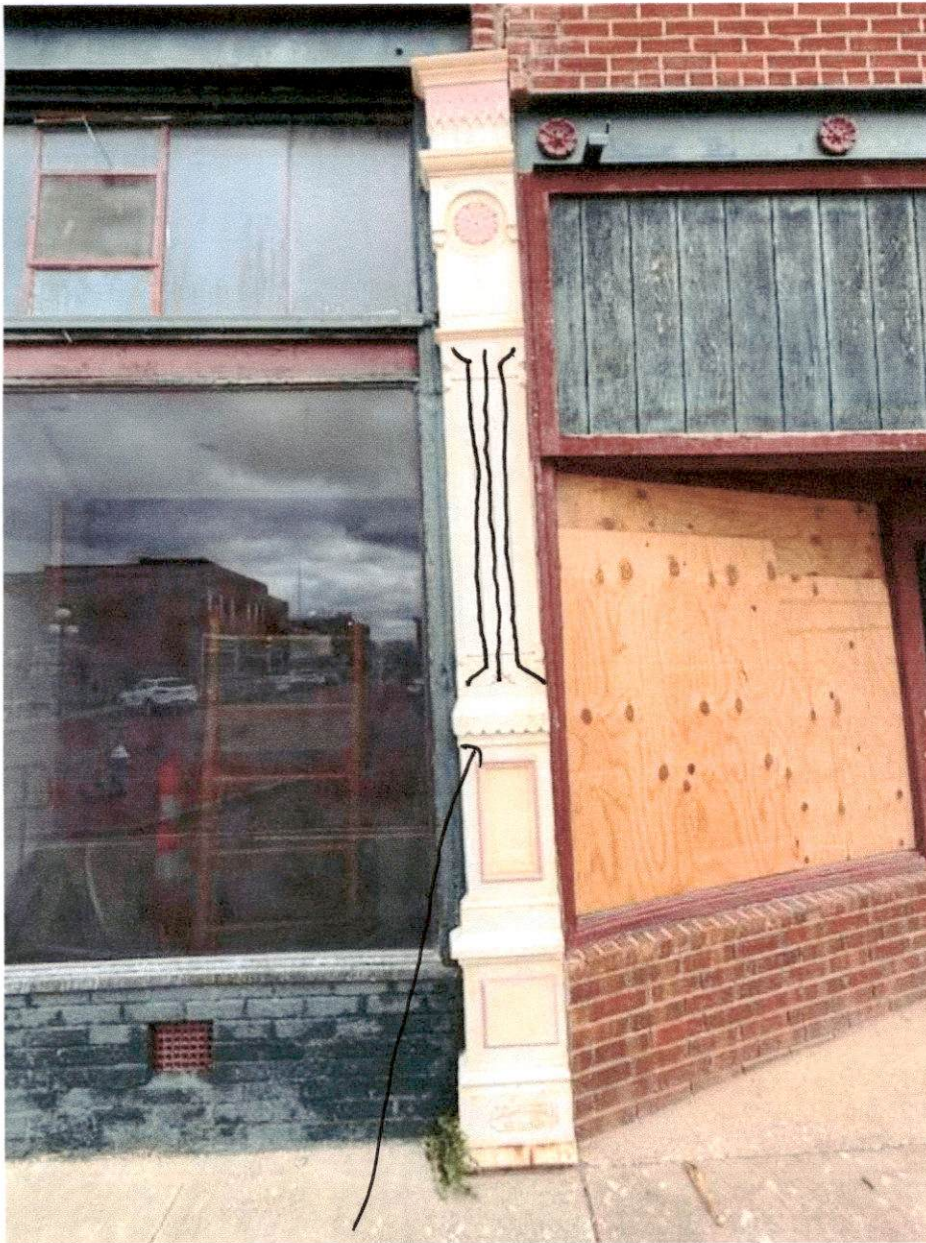
* storefront glass

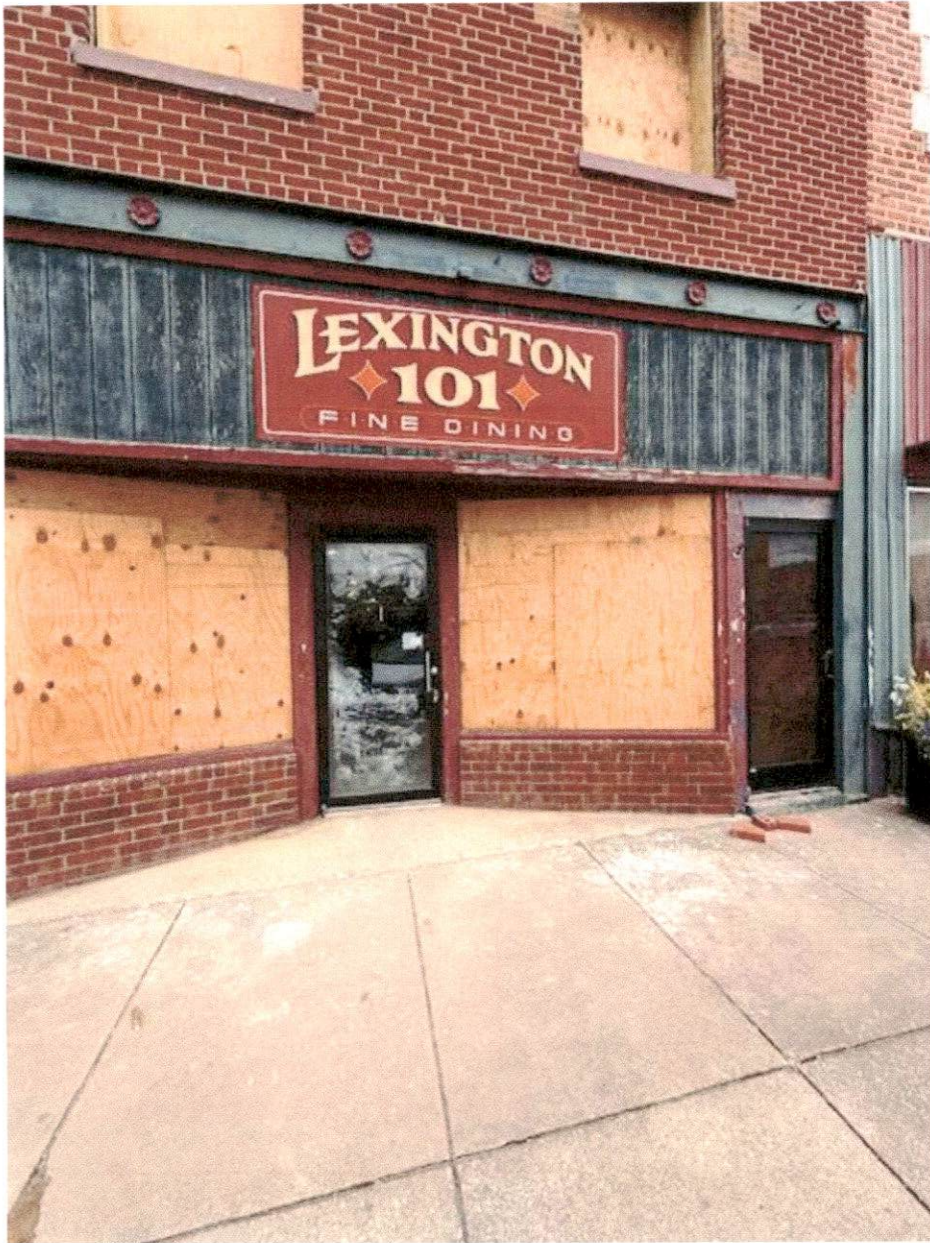
- Iron ore
- Natural Linen Accents

Staff recommends approval of the requested Certificates of Appropriateness with the suggestion that the proposed colors for the cast iron pilasters be reversed so that the lighter color (Natural Linen) is the primary and the details are painted the darker color (Iron Ore) to better maintain the integrity of the cast iron pilasters.

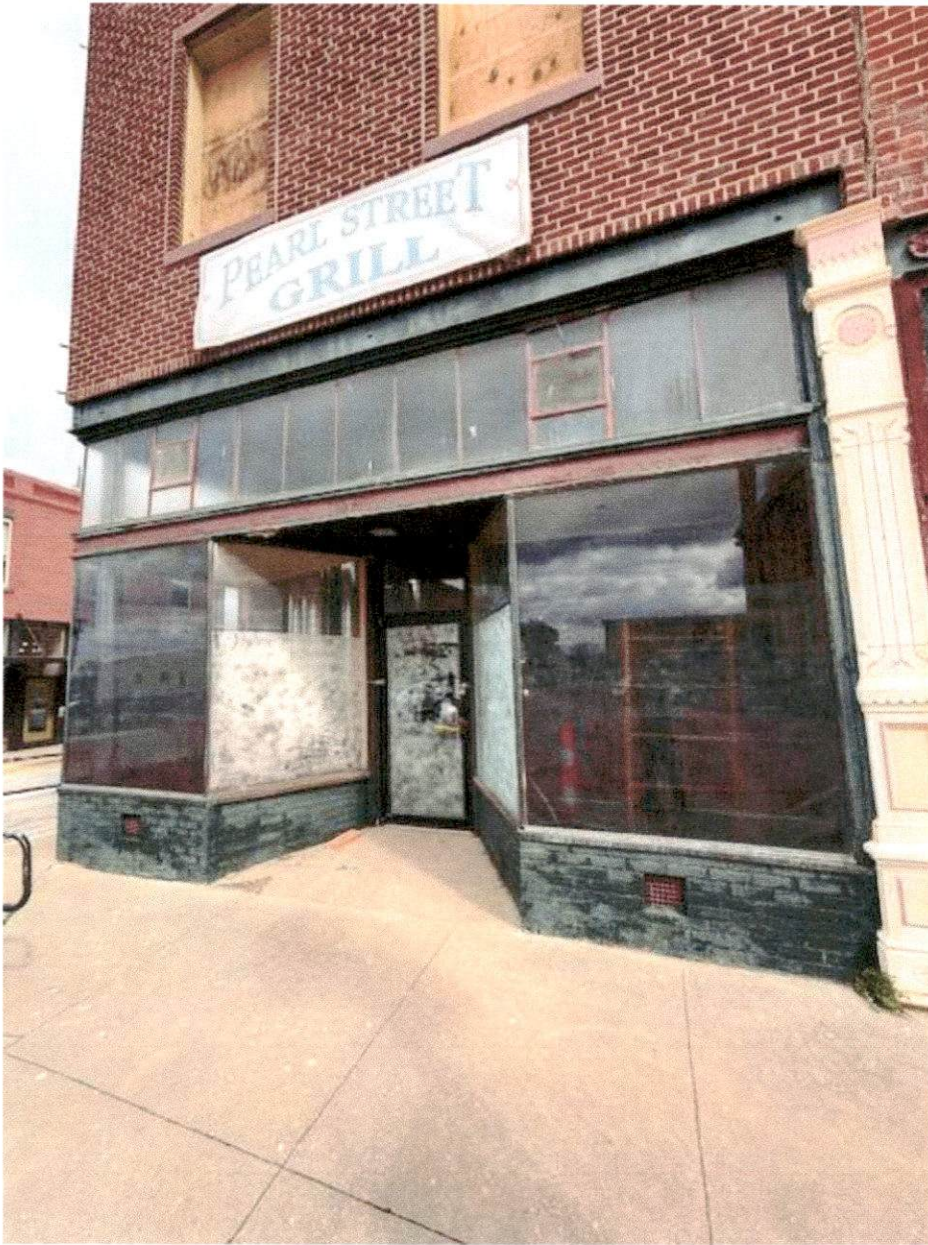
- All Green
Iron one

Add windows above
103 Door.

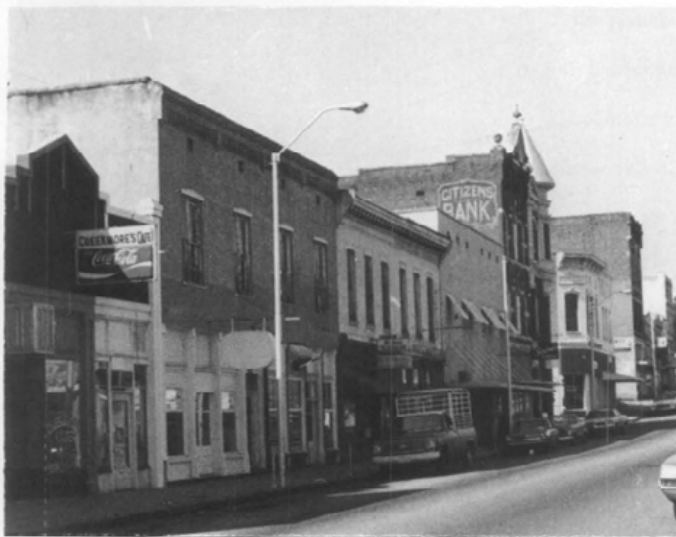
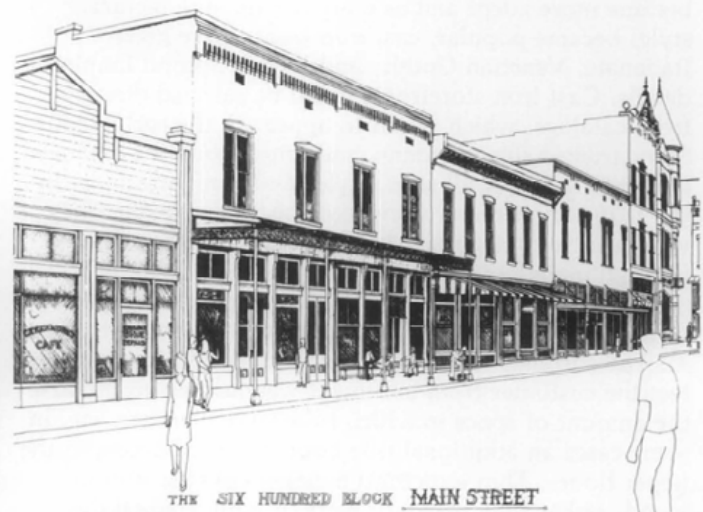
Figure 1. Inappropriate storefront alterations over the years—metal cladding, oversized signs and canopies—have detracted from the character of this historic district in Van Buren, Arkansas. A carefully considered rehabilitation plan for Main Street, including the removal of poorly designed signs, false fronts and the selection of an appropriate exterior paint color palette, serves to enhance the visual environment and preserves the district's sense of time and place. Photo above: Bob Dunn; Drawing, David Fitts

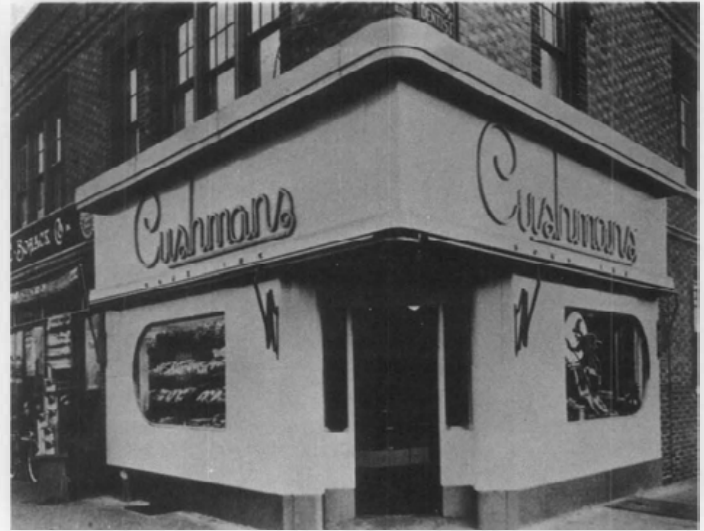
Figure 4. This storefront in New York City designed by Raymond Loewy typifies the streamlined look of the 1930's. Added to an earlier building, the front utilizes glass, stainless steel and neon to make a modern statement. This is a good example of a later storefront which has acquired significance and should be retained in any rehabilitation.

The first decades of the 20th century saw the growing use of decorative transom lights (often using small prismatic glass panes) above display windows; in some cases, these transoms could be opened to permit air circulation into the store. Electric incandescent lights enabled storeowners to call attention to their entrance and display windows and permitted nighttime shopping. In the 1920's and 1930's a variety of new materials were introduced into the storefront, including aluminum and stainless steel framing elements, pigmented structural glass (in a wide variety of colors), tinted and mirrored glass, glass block and neon. A bewildering number of proprietary products also appeared during this period, many of which went into storefronts including Aklo, Vitrolux, Vitrolite, and Extrudalite. Highly colored and heavily patterned marble was a popular material for the more expensive storefronts of this period. Many experiments were made with recessed entries, floating display islands, and curved glass. The utilization of neon lighting further transformed store signs into elaborate flashing and blinking creations. During this period design elements were simplified and streamlined; transom and signboard were often combined. Signs utilized typefaces for the period, including such stylized lettering as "Broadway," "Fino" and "Monogram." Larger buildings of this period, such as department stores, sometimes had fixed metal canopies, with lighting and signs as an integral component of the fascia (see figure 4).

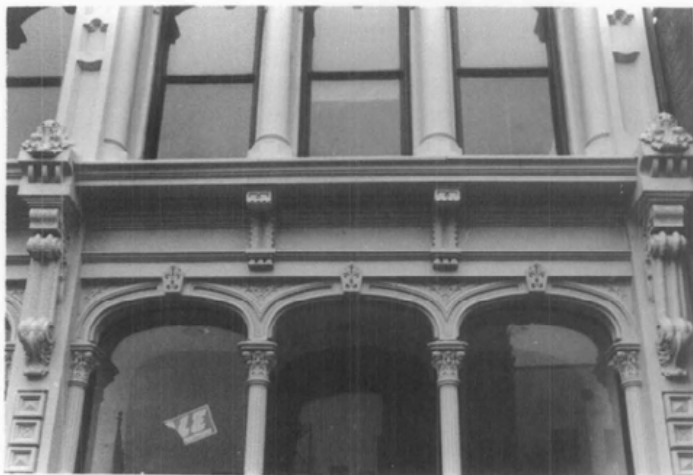
Figure 8. When the Grand Opera House in Wilmington, Delaware, was rehabilitated, missing cast-iron columns were cast of aluminum to match the original; in this particular case, because these columns do not carry great loads, aluminum proved to be successful substitute. Photo: John G. Waite

If metal components have deteriorated to a point where they have actually failed (or are missing), replacement is the only reasonable course of action. If the components are significant to the overall design of the storefront, they should be carefully removed and substituted with components that match the original in material, size and detailing (see figure 8).

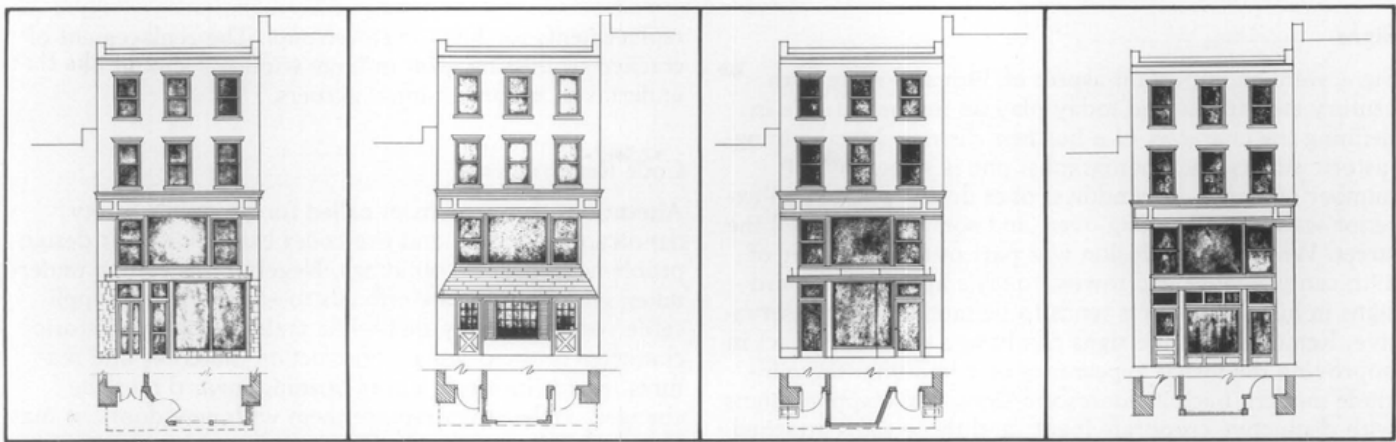
Figure 10. (A) This existing storefront, added in the 1950's to a late 19th century brick building, extends beyond the plane of the facade; faced with anodized aluminum and permastone, it does not contribute to the architectural and historic character of the building. (B) This replacement design uses "lumberyard colonial" detailing, such as barn-type doors, shutters, small paned windows, and a wood shake pent roof. The design, detailing, and choice of materials are clearly inappropriate to this commercial building. (C) This replacement design retains the 1950's projecting canopy but symmetrical placement of the doors relates well to the second floor windows above; this contemporary design is compatible with the scale and character of the building. (D) This replacement design accurately restores the original appearance of the building; based on historical research and physical evidence, it too is an acceptable preservation approach. Drawings: Sharon C. Park, AIA

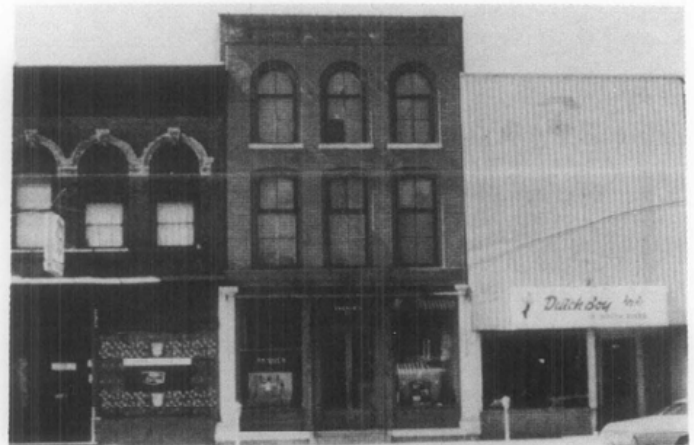
Figure 12. This photograph of three late 19th century commercial buildings clearly shows the impact of preserving and rehabilitating storefronts. The one on the right has been totally obscured by a "modern" front added in the 1950's. Although inappropriate alterations have taken place on the left storefront, it is still possible to determine the original configuration of the doors and display windows. The storefront in the middle has remained intact. Although in need of some minor maintenance work, the appeal of the original design and materials is immediately apparent.

A key to the successful rehabilitation of historic commercial buildings is the sensitive treatment of the first floor itself (see figure 12). Wherever possible, significant storefronts (be they original or later alterations), including windows, sash, doors, transoms, signs and decorative features, should be repaired in order to retain the historic character of the building. Where original or early storefronts no longer exist or are too deteriorated to save, the commercial character of the building should nonetheless be preserved—either through an accurate restoration based on historic research and physical evidence or a contemporary design which is compatible with the scale, design, materials, color and texture of the historic building. The sensitive rehabilitation of historic storefronts will not only enhance the architectural character of the overall building but will contribute to rejuvenating neighborhoods or business districts as well.

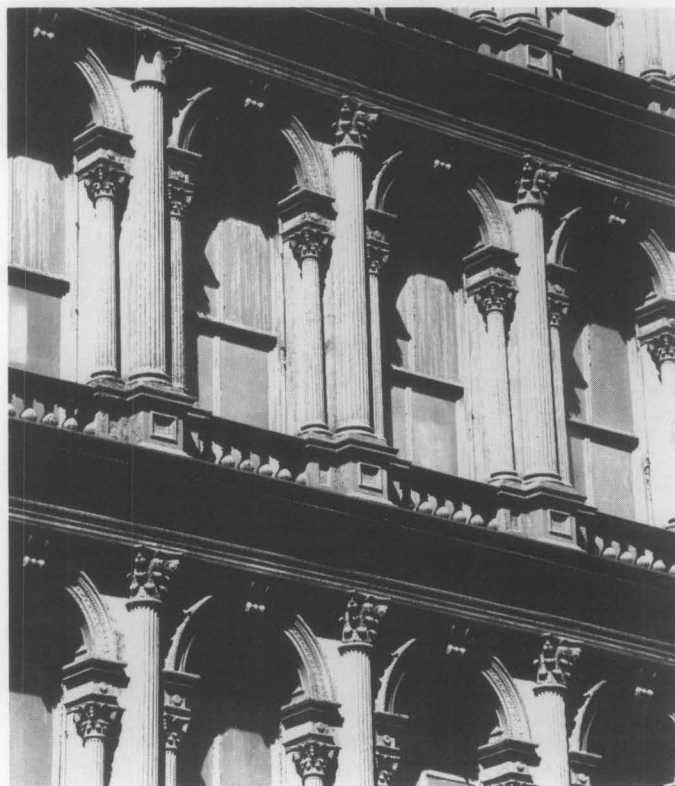
Fig. 1. The Haughwout Building in New York City is an excellent example of the quality and character of mass-produced cast-iron architecture. Once wood patterns were made, any number of elements could be cast, as was done with each of these repetitive bays. Photo: New York City Landmarks Preservation Commission.

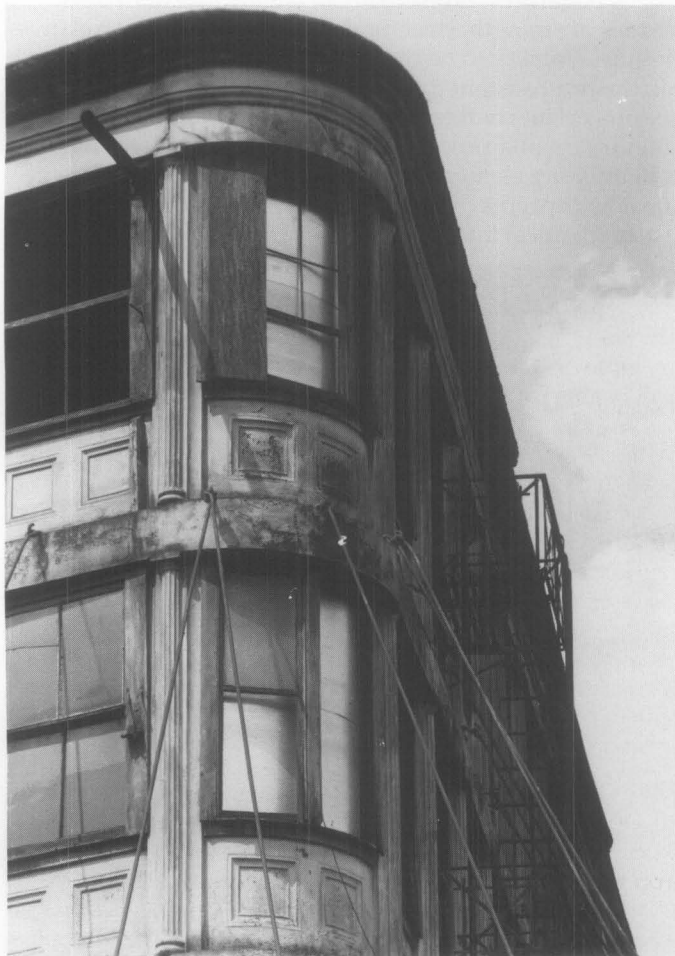
Fig. 2. The Edgar Laing Stores Block in New York City was designed by James Bogardus. It was the first building constructed with facades of self-supporting cast iron. This corner view shows the Doric-style engaged columns, panels, and spandrel beams; the loss of most of the original ornamental castings give it an austere look. As part of an urban renewal project, the facades were carefully disassembled in 1971 for later re-erection in another location—only to have its iron parts stolen for scrap. Photo: Jack E. Boucher, HABS Collection.

In 1849 Bogardus created something uniquely American when he erected the first structure with self-supporting, multi-storied exterior walls of iron. Known as the Edgar Laing Stores, this corner row of small four-story warehouses that looked like one building was constructed in lower Manhattan in only two months. Its rear, side, and interior bearing walls were of brick; the floor framing consisted of timber joists and girders. One of the cast-iron walls was load-bearing, supporting the wood floor joists. The innovation was its two street facades of self-supporting cast iron, consisting of multiples of only a few pieces—Doric-style engaged columns, panels, sills, and plates, along with some applied ornaments (cover photo and Fig. 2). Each component of the facades had been cast individually in a sand mold in a foundry, machined smooth, tested for fit, and finally trundled on horse-drawn drays to the building site. There they were hoisted into position, then bolted together and fastened to the conventional structure of timber and brick with iron spikes and straps (Fig. 3).

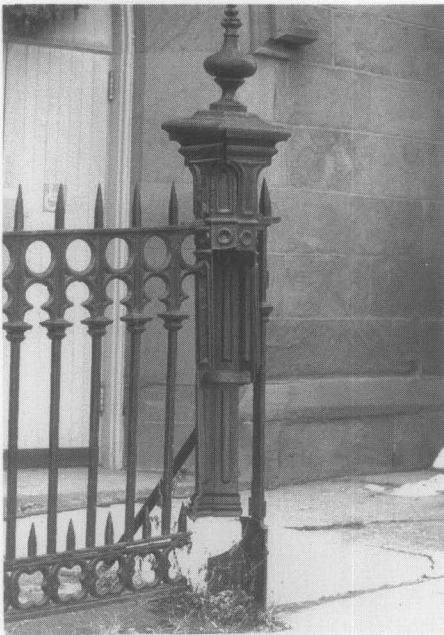
Fig. 7. Despite an impact that shattered the main castings, this fence post remains upright, demonstrating the great strength of cast iron. Originally, the post was held together by a long bolt that extended from the finial to the base. Photo: John G. Waite.

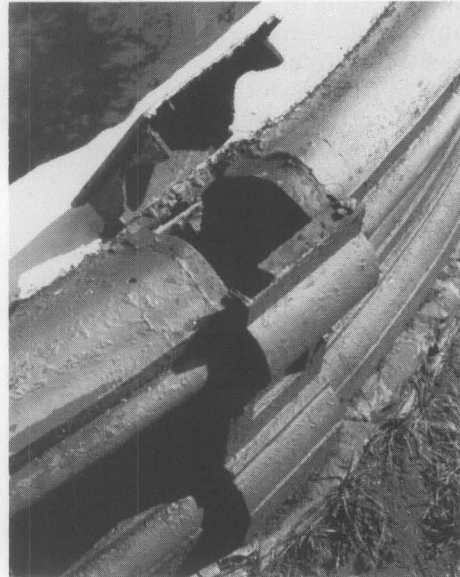
Fig. 9. Galvanic corrosion occurred where a patch of copper was installed alongside the cast-iron cap at the base of a fountain. The use of terne-coated stainless flashings with appropriate caulking would have been a more suitable repair. Photo: John G. Waite.

Galvanic corrosion is an electrochemical action that results when two dissimilar metals react together in the presence of an electrolyte, such as water containing salts or hydrogen ions (Fig. 9). The severity of the galvanic corrosion is based

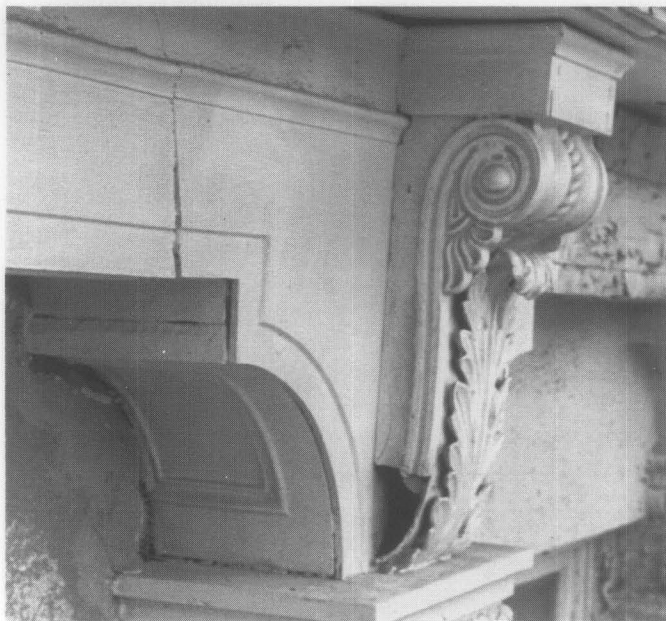
Fig. 8. Structural cracks, gaps at joints between components, and a large opening where part of the console bracket is missing are the problems evident in this cast-iron assembly. Photo: Ford, Powell & Carson.

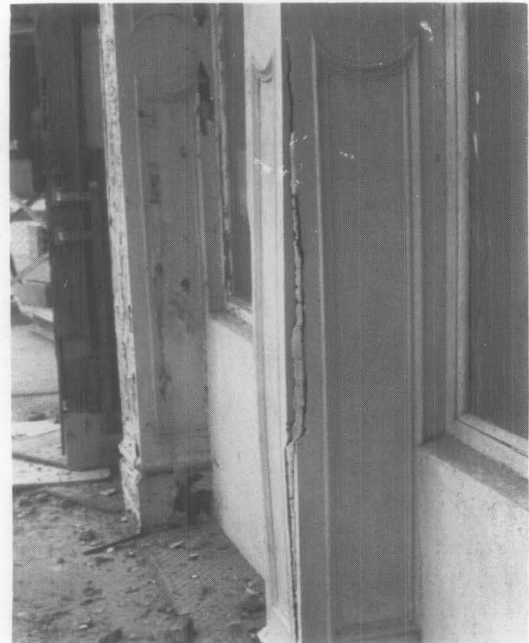
Fig. 11. Major cracks in the piers of this cast-iron storefront in Galveston, Texas resulted from the transfer of load onto the iron from internal brick piers eroded by rising damp. This crack was inappropriately filled with concrete, which trapped moisture and accelerated internal corrosion, pushing the iron further apart. Photo: Ford, Powell & Carson.

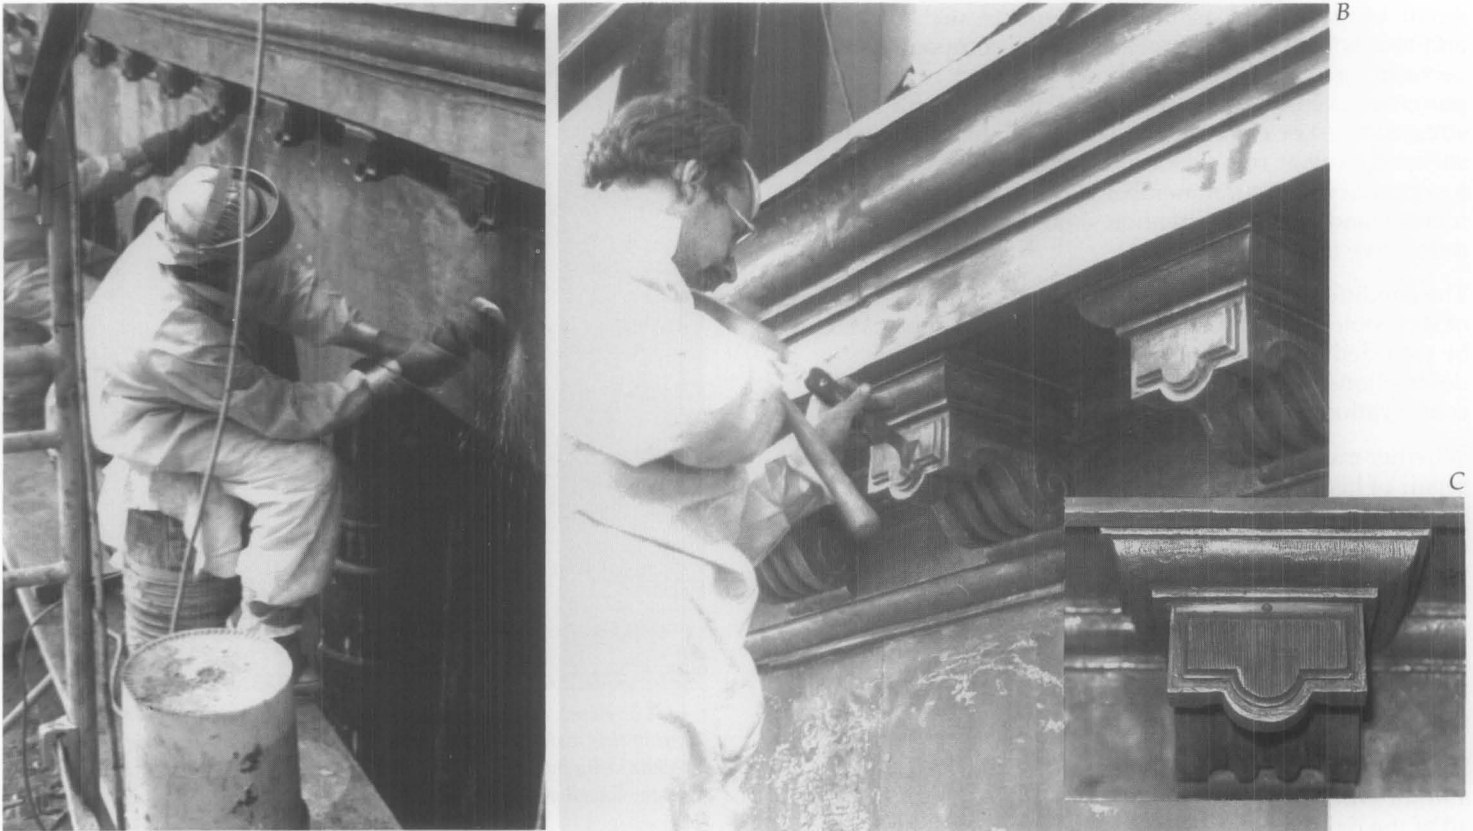
Fig. 13. Surface preparation may involve several different techniques. Where chemical paint stripping is involved, careful planning of the sequence of work and inspection by an architect or conservator to ensure strict compliance with the contract documents is important to minimize the risk of problems. After the chemical paste and paint was scraped off, the remaining paint and chemical residue were removed with a wire brush (a) and scrapers selected or cut to fit the shape of the iron surfaces (b). The surface was then wiped with solvent to create a completely clean surface prior to repainting (c). Photos: Raymond M. Pepi, Building Conservation Associates.

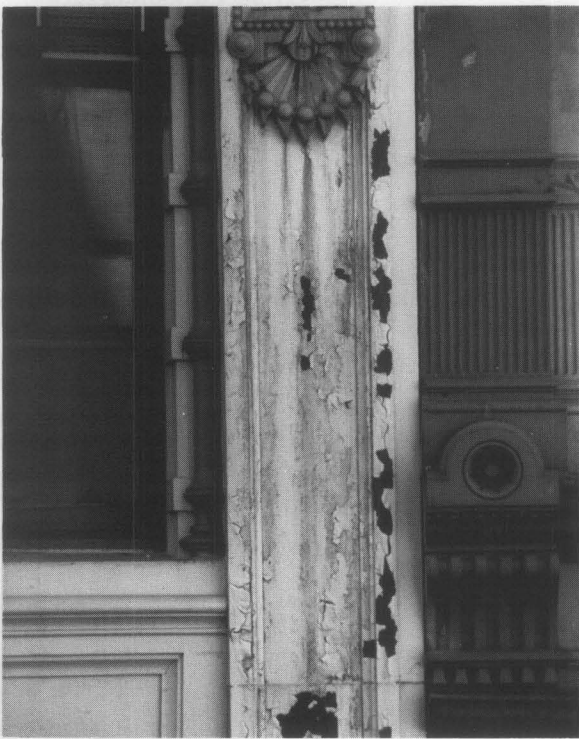
Fig. 14. Major problems can result if work is undertaken without proper sequencing and precautions. On this building, a strong alkaline paint remover was used, and apparently was not adequately rinsed or neutralized. Over a period of months, the newly applied paint began to peel and streaks of rust appeared on the iron. Photo: Kim Lovejoy.

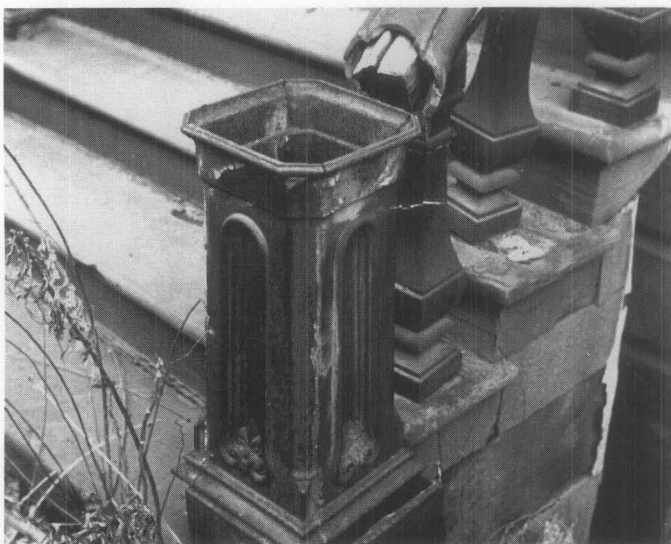
Fig. 15. In an effort to repair this stair railing, concrete was poured around the wood spacer inside the railing casting. Water penetrated the railing and reacted with the concrete to accelerate the corrosion of the iron. Photo: John G. Waite.

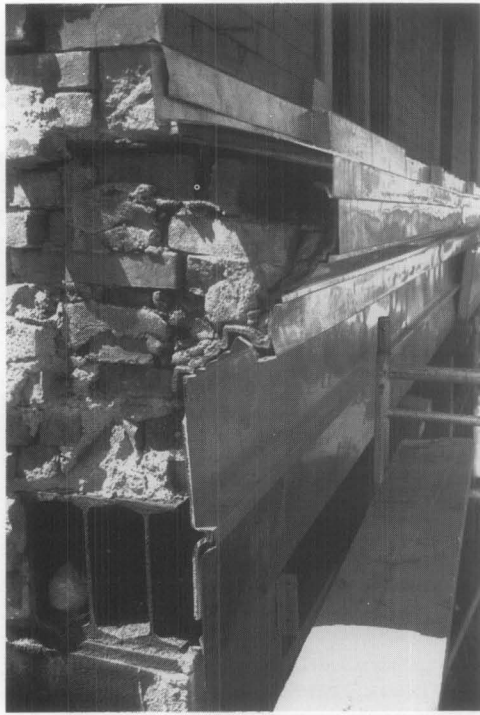
Fig. 18. This cast-iron storefront cornice was corroded beyond the point of repair, and could not be removed easily for replacement. Terne-coated stainless steel, the most durable metal for flashing cast iron, was applied to the cornice and fitted as closely as possible to the historic profile. Although painting is not necessary to protect terne-coated stainless steel, the cornice should be painted to be consistent with the historic character of the building. A primer which is compatible with the terne coating should be used. Photo: Dean Koga, Robert E. Meadows, P.C., Architects.

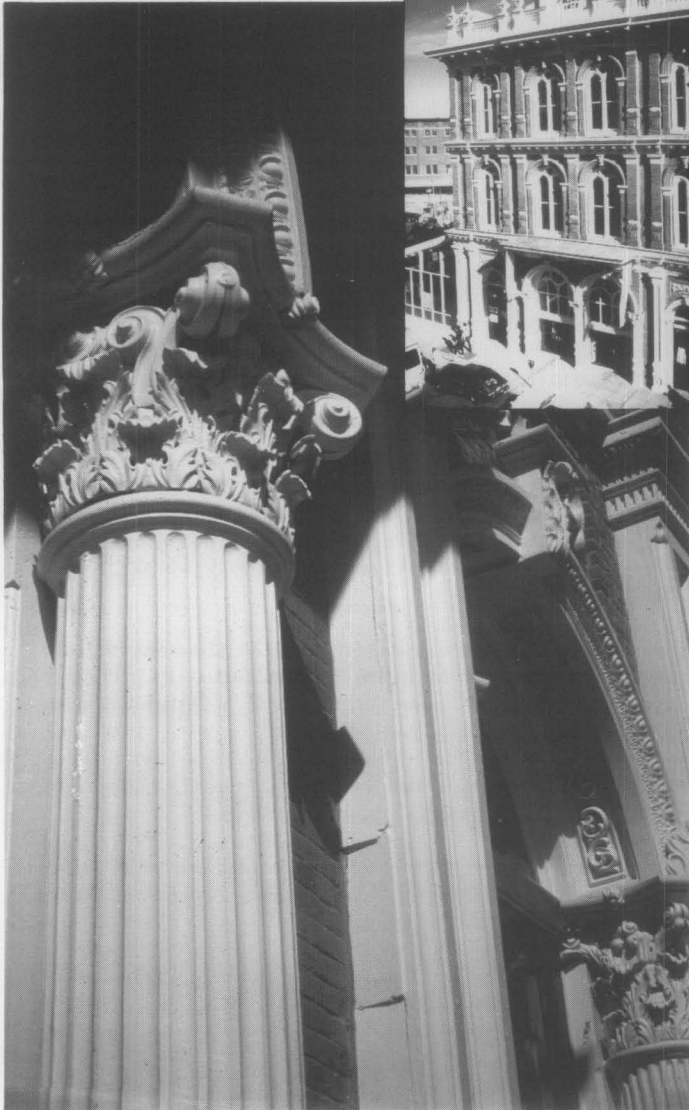
Fig. 19. (a) Fiberglass columns and aluminum capitals were installed to replicate the ornamental features on the east facade of the New Market Theater in Portland, Oregon, that had been destroyed by previous occupants. Like cast iron, crisp ornamental details can be achieved with cast aluminum. Although aluminum may be in contact with fiberglass, galvanic corrosion may result when aluminum is in direct contact with cast iron. Photo: William J. Hawkins, III. (b) The west facade of the theatre retains its original cast iron features. Photo: George McMath.

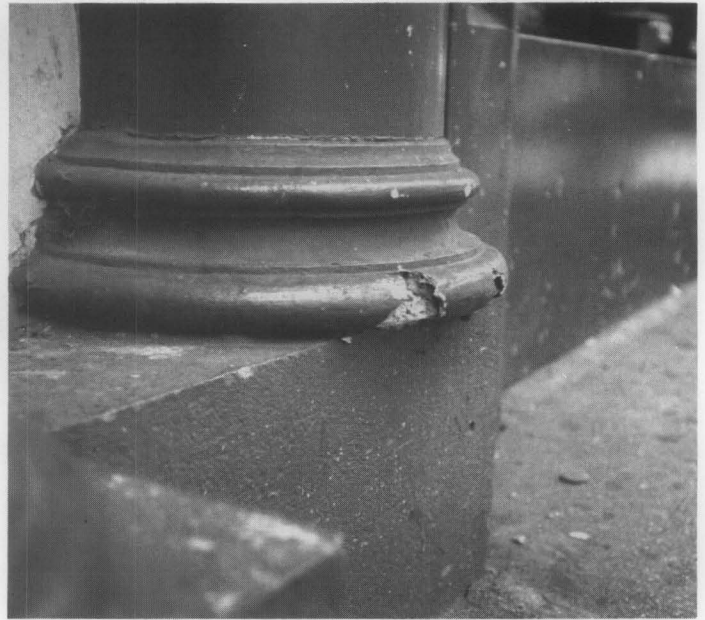
Fig. 20. The location of the feature must be taken into account if a substitute replacement material is being considered. This lightweight fiberglass column at street level sustained damage from impact within a few years of installation. The great strength of cast iron makes it ideal for storefronts and elements that must withstand heavy use. Photo: Building Conservation Associates.

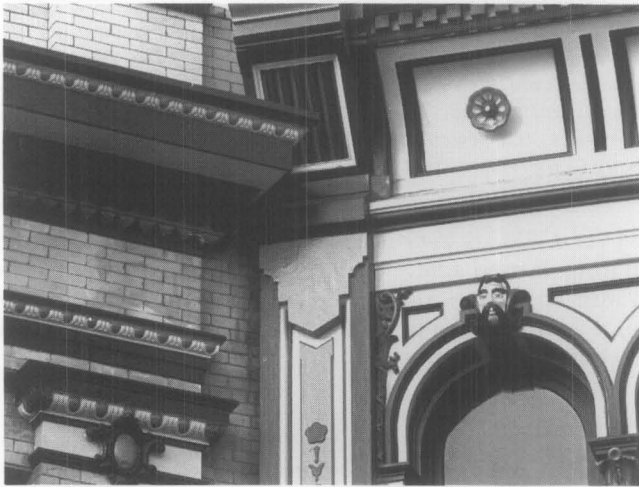
Detail of polychromed cast-iron facade at 23 Petaluma Boulevard, Petaluma, Calif. (1886; O'Connell and Lewis, *Architectural Iron Work*, San Francisco). Photo: Don Meacham.
